SCIENCE PROGRAM BRIEFING:

Public Law 112-149 Continued Monitoring of Runit Island

*U.S. DOE-GRMI Annual Meeting
Majuro
Republic of the Marshall Islands
May 15-16, 2019*

- **2013, Together with external consulting experts, successfully completed and published an initial engineering and visual survey of the concrete cap covering the waste containment structure**

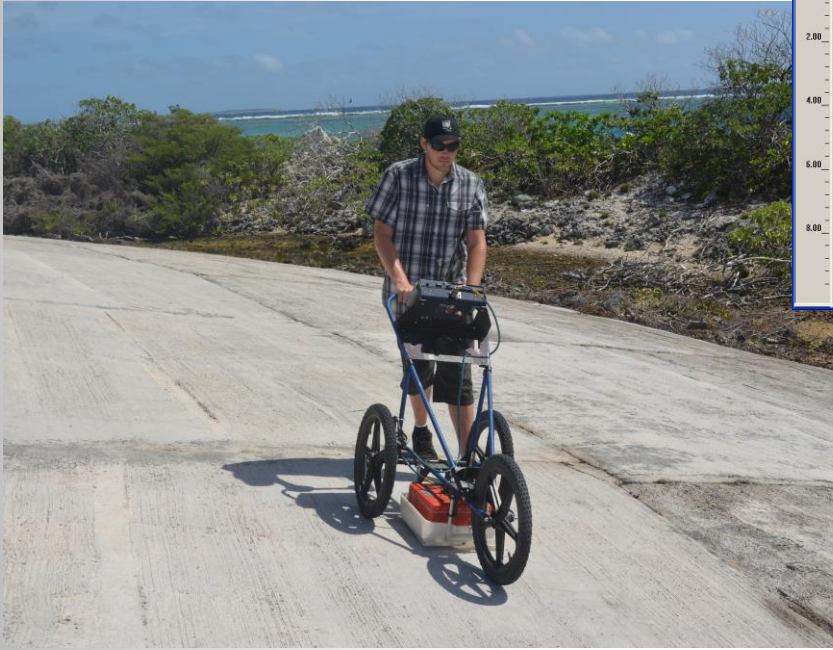
Ground Penetrating Radar

[Nondestructive testing of the integrity of the concrete to identify voids (air pockets) and other reflective anomalies down through the waste pile]

[Provided a measure of the thickness of the concrete cap]

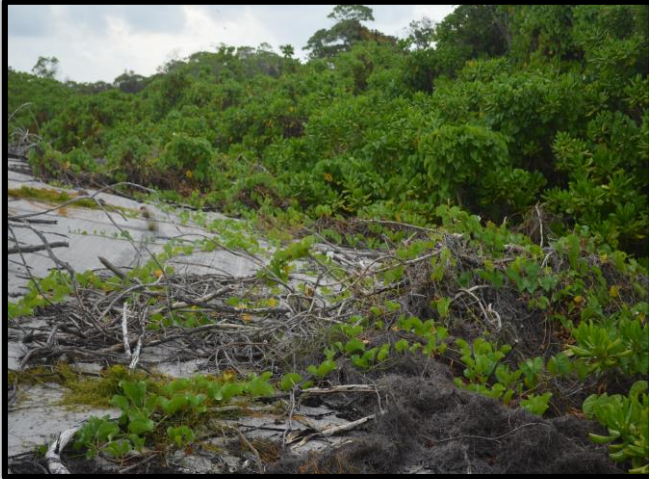
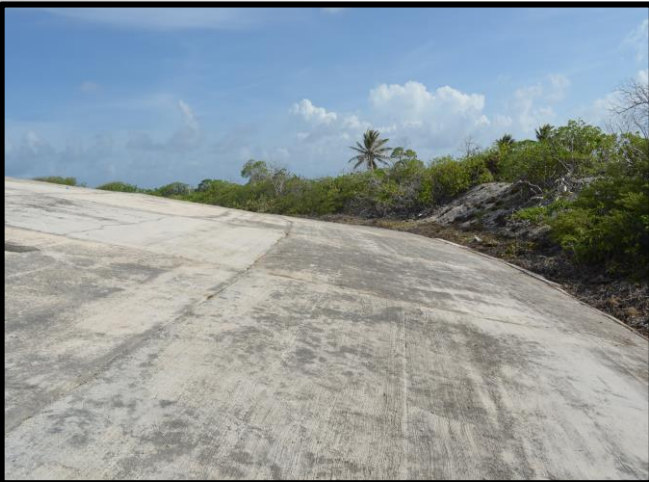
> 2018, Conducted a visual survey of the waste containment structure

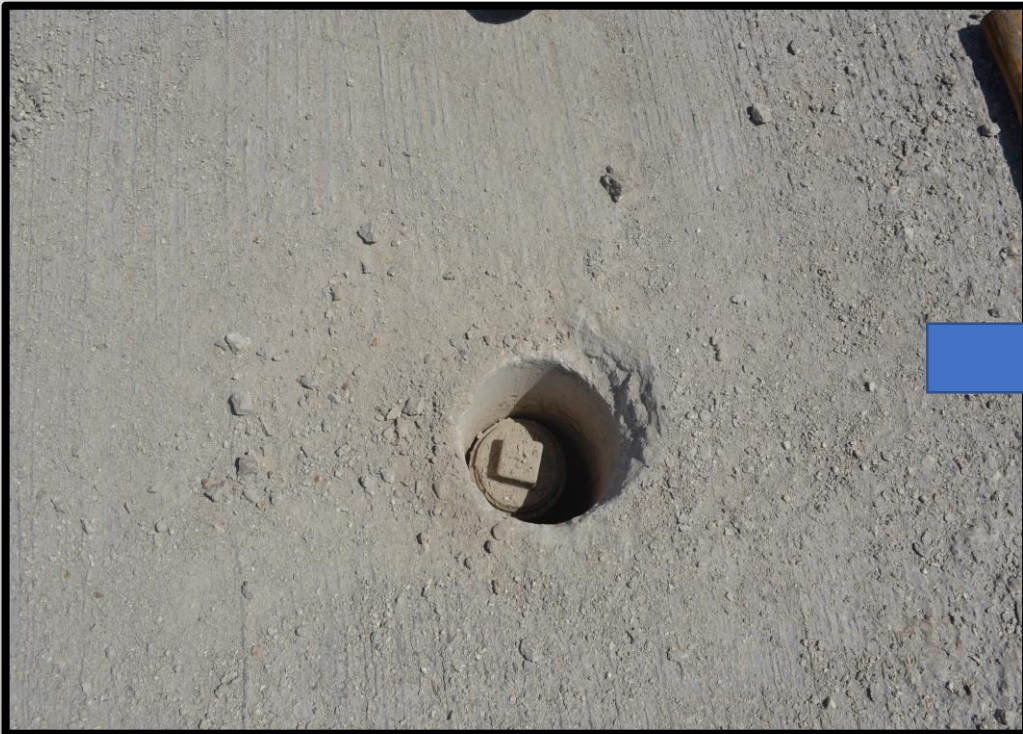
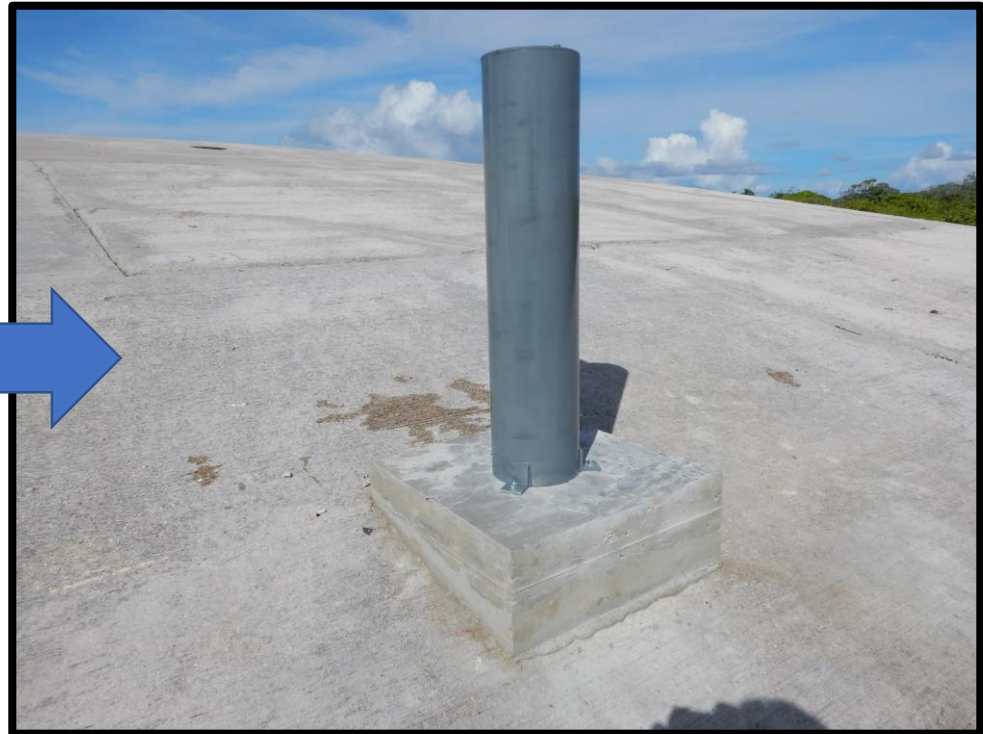
- 2013, Re-established and conducted initial pump tests on National Academy of Sciences (NAS) boreholes positioned on and around the containment structure
- 2013-2018, Collected initial sets of groundwater samples from on and off the containment structure for measurement of radionuclides and other water quality parameters

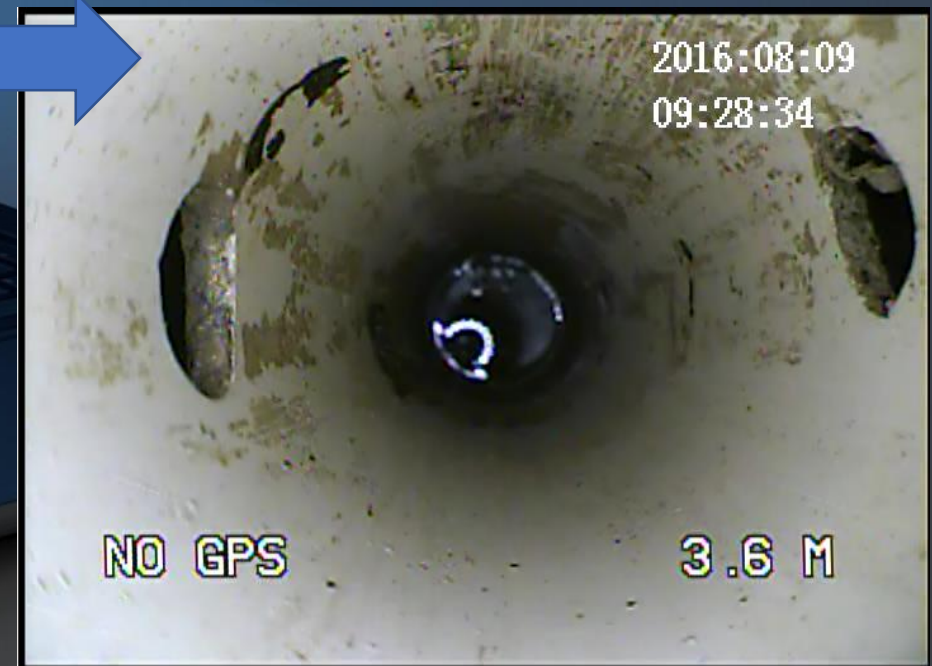
(salinity 2-4 ppt, pH ~ 12.4)

Initial Measurement of Fallout Radioactivity in the *Runit Dome Borehole*

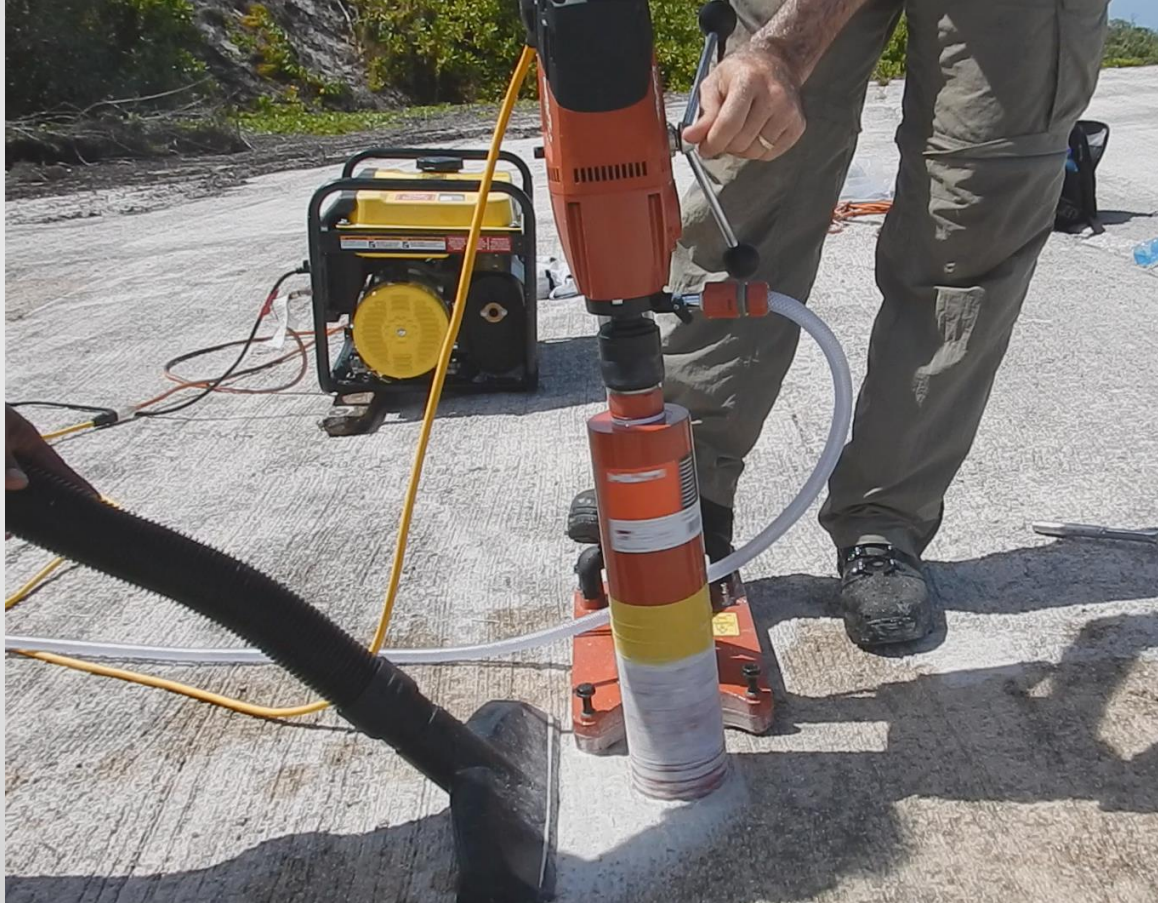
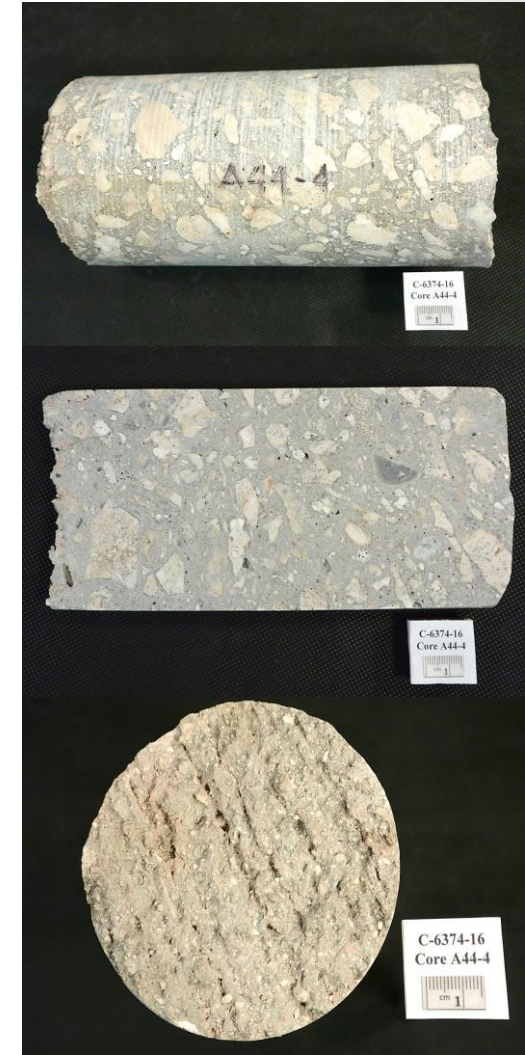
➤ Chemical and Compression Strength Testing of Concrete Cores

- Aggregate materials were well graded, properly shaped, uniformly distributed, and hard to fairly hard
- No excessive fines or 'dirty' aggregate were found
- Concrete was not air-entrained
- Longitudinal and transverse small macro-cracks were generally limited to the exterior surfaces of the concrete
- Thin sections revealed a wide range of micro-cracking between the cores
- Compressive strength of concrete 4500-10,000 psi
- Load capacity = 49,000-111,000 lbs

Conclude that micro-cracking and small macro-cracks along the exterior portion of the concrete do not appear to be adversely affecting the strength properties or integrity of the concrete

- **Continue to provide maintenance activities of the concrete façade covering the containment structure to include removal of rooting vines, and repair of concrete spalls and cracks**
